Curtis Creek Watershed Diagnostic Study

NEWTON AND JASPER COUNTIES, INDIANA

April 11, 2003

CURTIS CREEK WATERSHED DIAGNOSTIC STUDY EXECUTIVE SUMMARY

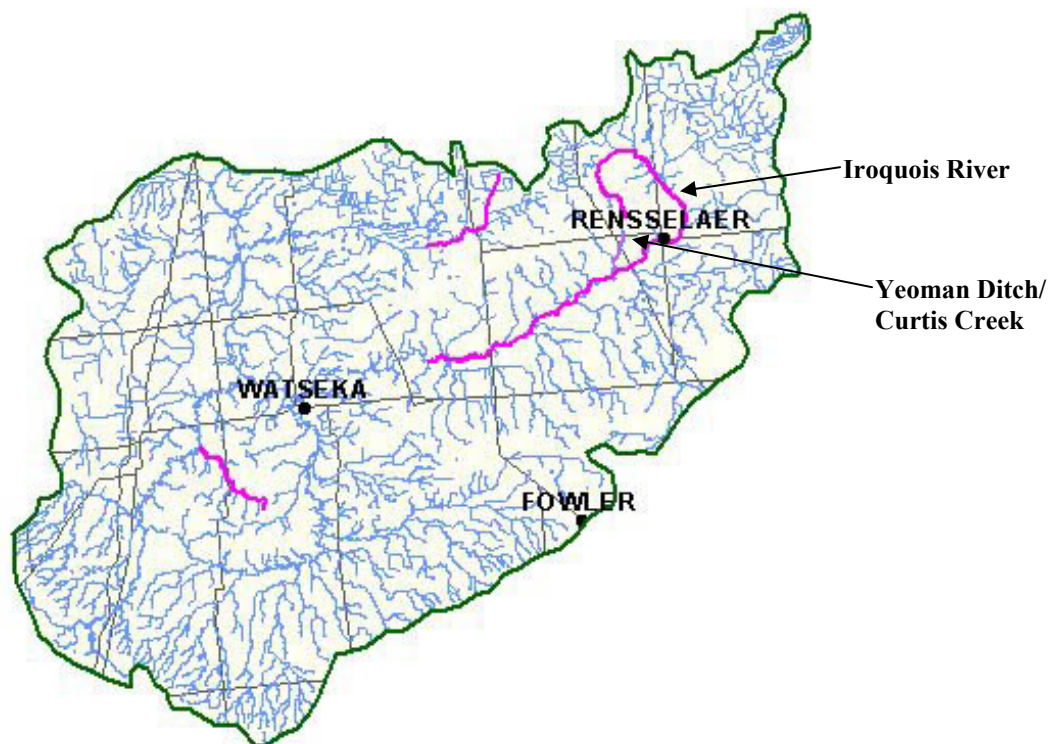
FIGURE 24. 303(d) listed waterbodies in the Iroquois River Basin. All bodies of water are displayed on the map. Those waterbodies included on the 303(d) list are highlighted in pink.

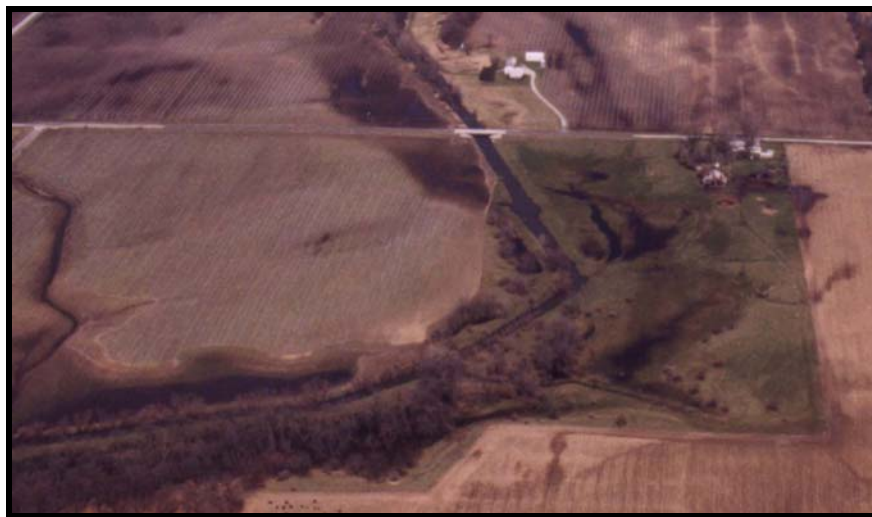
FIGURE 26. Site A9 showing area of heavy grazing in the Mouth of Curtis Creek Subwatershed.

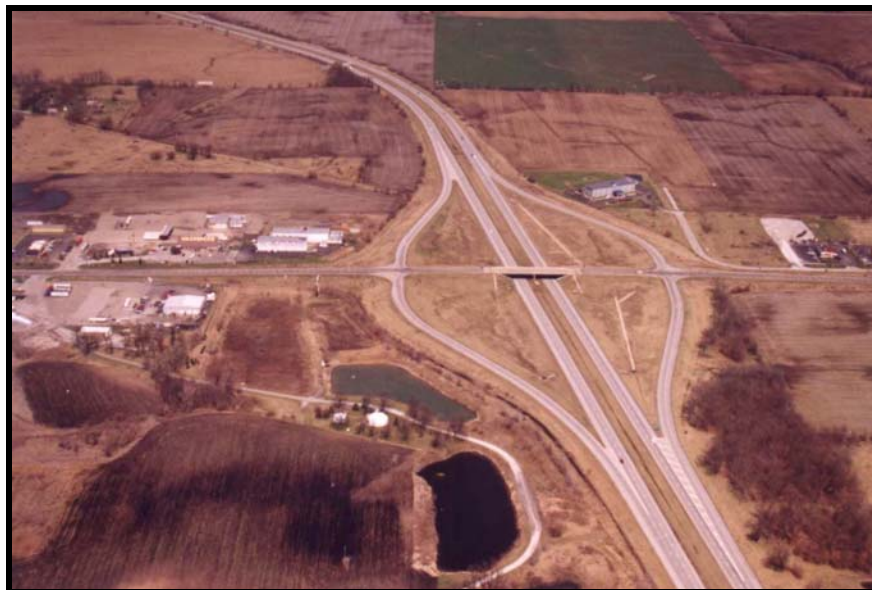
FIGURE 27. Site A3 showing a potential wetland restoration site in the Yeoman Ditch Subwatershed.

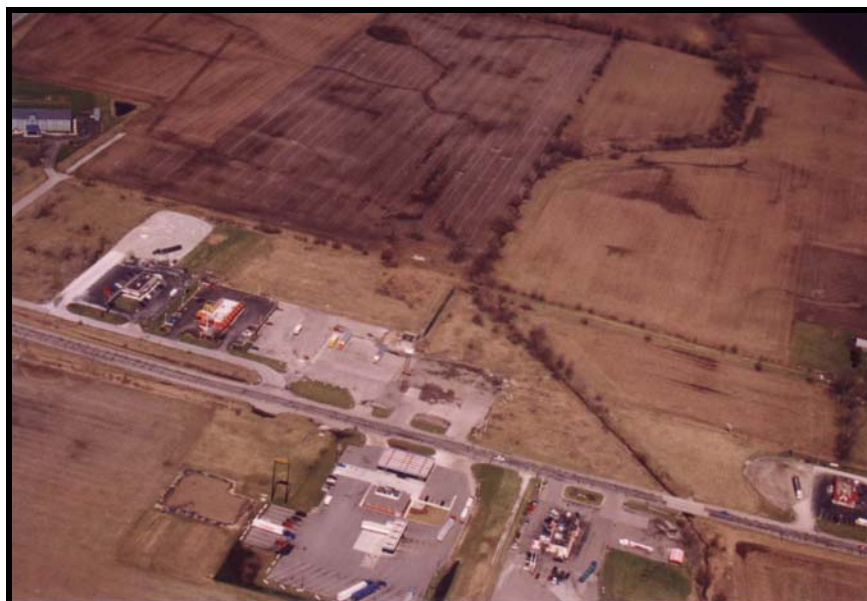
FIGURE 28. Site A55 showing a portion of the commercial development at the intersection of SR 114 and I-65.

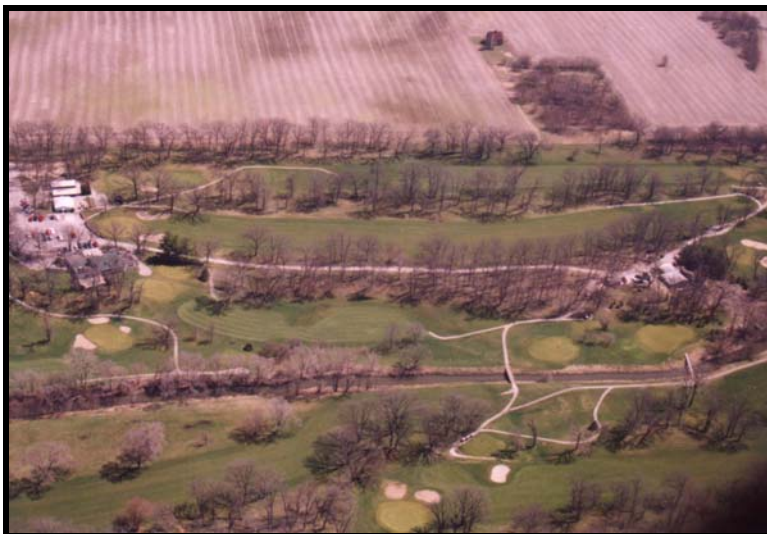
FIGURE 29. Site A56 showing the Curtis Creek Golf Course.

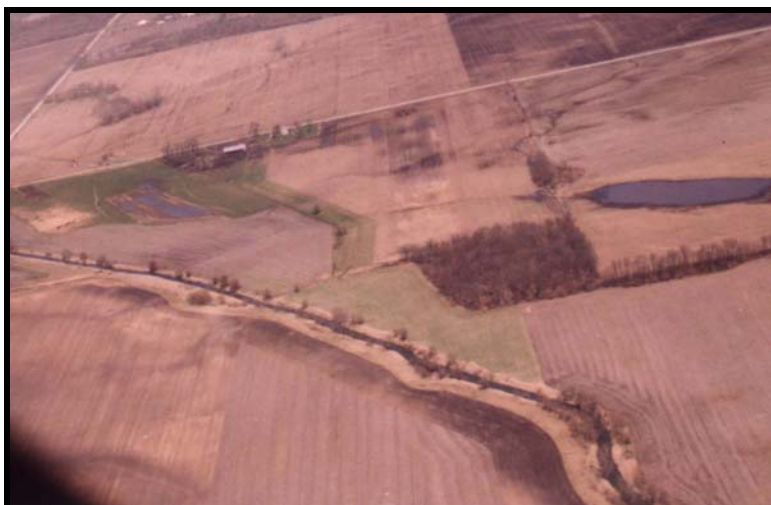
FIGURE 30. Site A23 showing representative need for filter strips (east stream bank) in the State Road 114 Subwatershed.

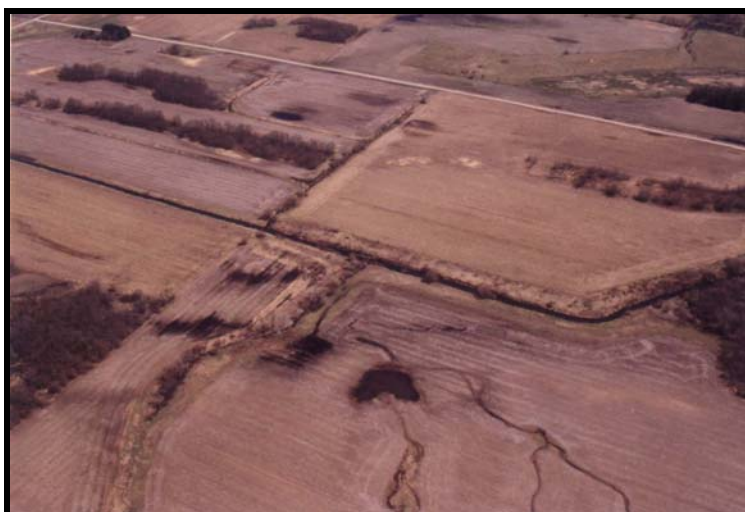
FIGURE 31. Site A35 showing representative need for grassed waterway installation.

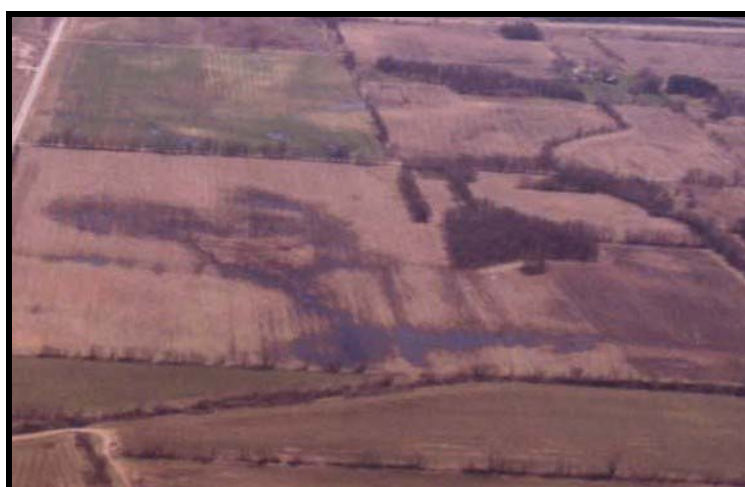
FIGURE 32. Site A37 showing potential wetland restoration site.

County Road 100 South Subwatershed. Seven areas that would benefit from management practices were documented during the aerial tour of the County Road 100 South Subwatershed (Table 49; Sites A31-A37; Figure 25). Riparian revegetation and filter strip or grassed waterway construction would help to slow erosion at six of the sites. Figure 31 shows gully and rill erosion indicative of the need for grassed waterway installation. Site A37 (Figure 32) also offers potential for a wetland restoration project which would expand water-holding capacity in the watershed and help slow erosion processes downstream. (This wetland lies on the Kosta Ditch-County Road 100 South Subwatershed boundary.)

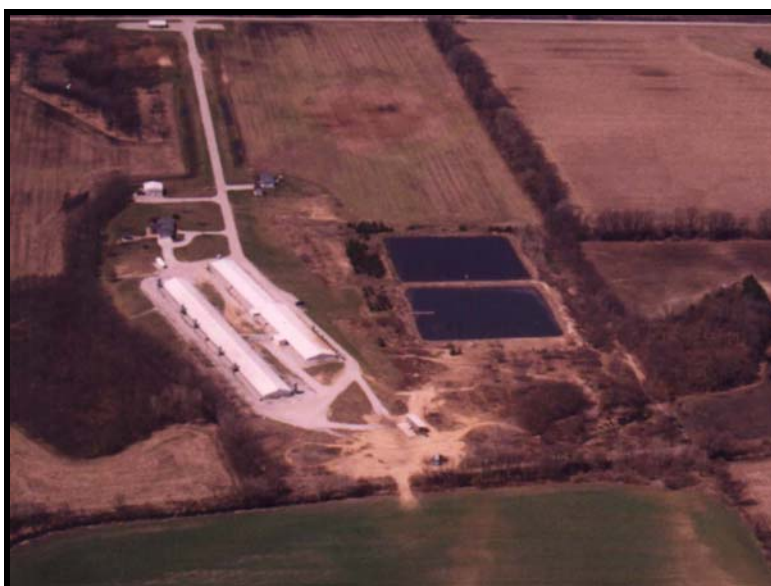
FIGURE 33. Site A60 showing a hog farm adjacent to a tributary to Elijah Ditch.

Elijah Ditch Subwatershed. Aerial photo documentation of the Elijah Ditch Subwatershed only revealed four locations in the headwaters where land management actions could improve water quality (Table 50; Sites A38 to A42; Figure 25). Photos also identified one potential pollution area: a hog farm containing approximately 2,500 head of hogs located adjacent to an unnamed tributary to Long Ditch (Figure 33). Photos of the downstream reach of Elijah Ditch were not detailed enough to discern individual problems. For this reason, additional time was spent in the Elijah Ditch area during the windshield survey. The area will be discussed in more detail in the Windshield Survey Section.

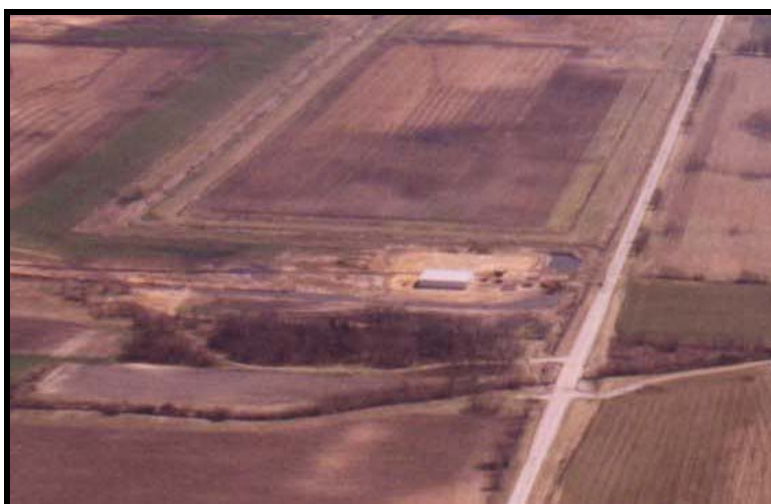
FIGURE 34. Site A61 showing construction of a milk-truck washing facility in the Headwaters Subwatershed. Once complete, the facility will be utilized to rinse milk trucks with chlorinated water, which will then be held in wastewater ponds for primary treatment.

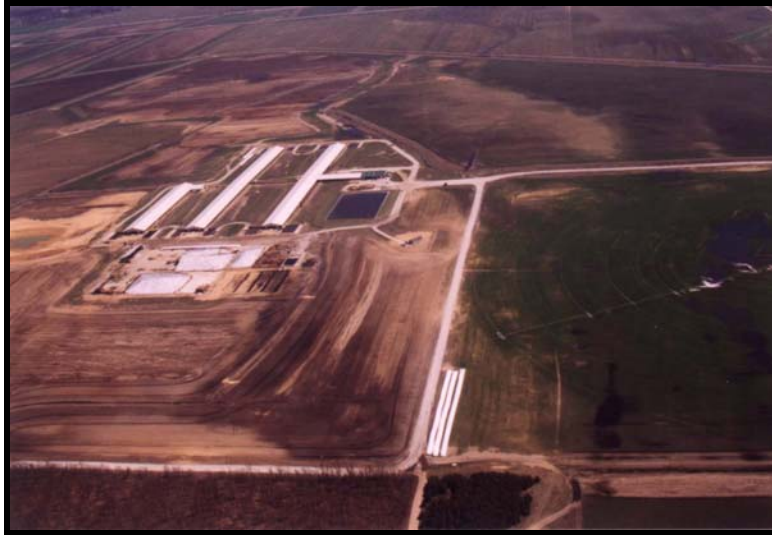
FIGURE 35. Site A62 showing one of the Fair Oaks Dairy barns.

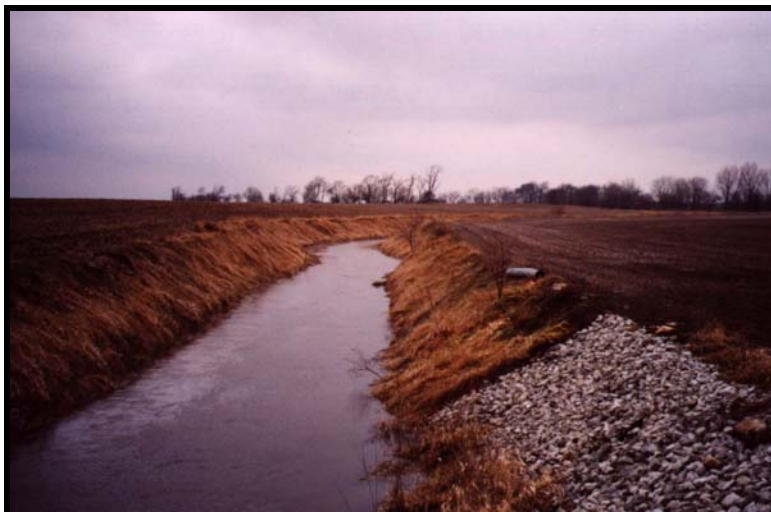
FIGURE 37. Site W7 taken during the windshield survey showing the need for filter strips and bank revegetation in the Golf Course Subwatershed.

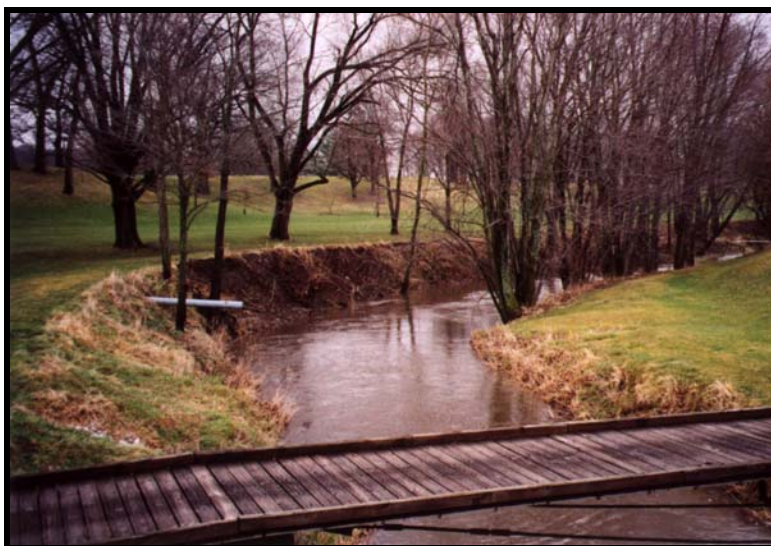
FIGURE 38. Site W8 taken during the windshield survey showing unstable banks and the need for increased riparian vegetation width in the Golf Course Subwatershed.

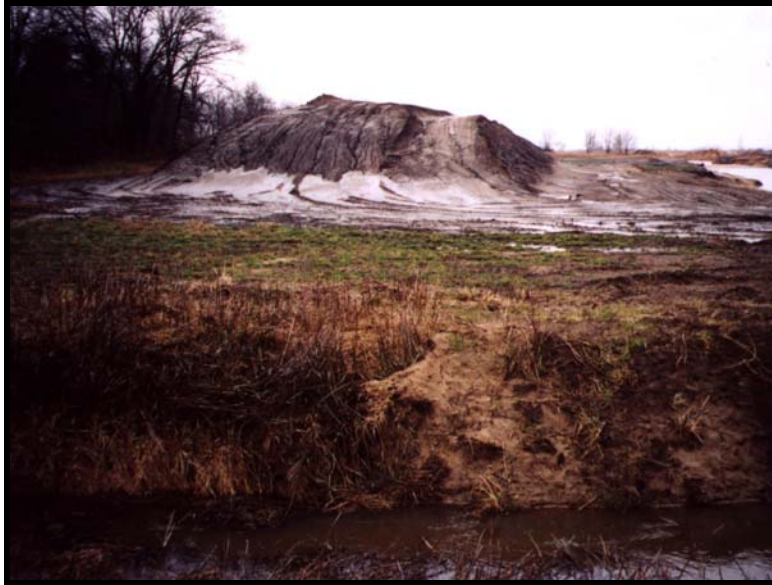
FIGURE 39. Site W27 taken during the windshield survey showing unstable banks and the need for erosion control in the Headwaters Subwatershed.

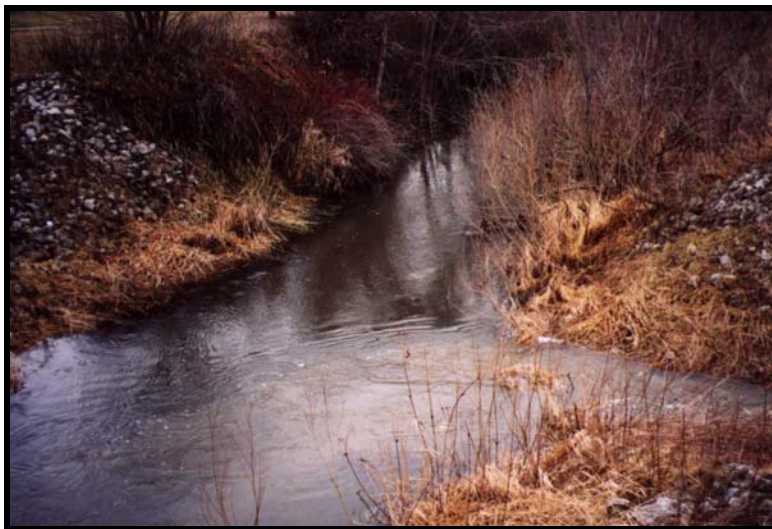
FIGURE 40. Site W31 taken during the windshield survey showing a sediment plume from a surface drainage tile in the Headwaters Subwatershed.

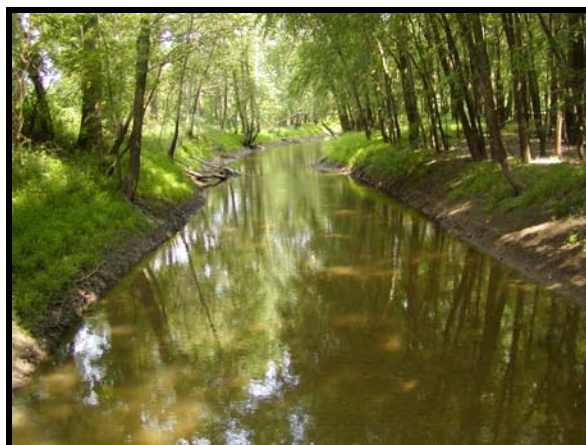
Site 1 – Mouth of Curtis Creek. The QHEI score at this site was 42 of 100 total possible points, the second highest of any of the study streams. The substrate was 95% sand and 5% silt. Substrate embeddedness was extensive; heavy silt cover was also present. In-stream conditions were poor with low substrate stability and poor riffle and pool development. Second growth trees dominated the riparian vegetation. The trees provided both canopy and in-stream cover in the form of root wads, logs, and woody debris (Figure 62). The creek at this site had one of the widest stream channels of any in the study area (8.3 feet; Figure 61). The mIBI score for the site was 4.75, the second highest of any of the Curtis Creek sites. The highly intolerant *Planaria* taxon *Planaria* was the dominant taxon sampled at this site. However,

moderately tolerant taxa from the taxon *Diptera* composed a large portion of the “slightly” impaired macroinvertebrate community. This indicates the water and habitat quality were relatively unimpaired within this reach of Curtis Creek compared to other study reaches.

FIGURE 62. Site 1 sampling location on Curtis Creek.

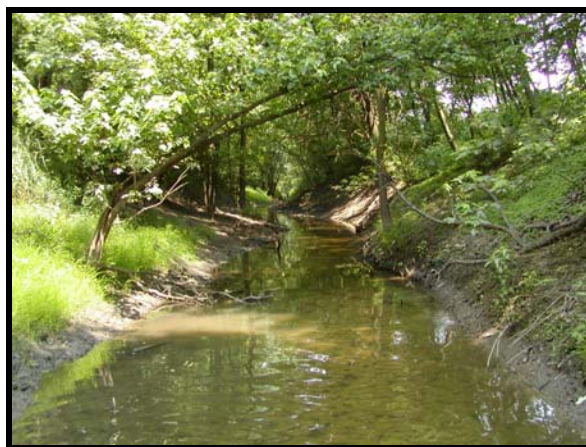
Site 2 – Yeoman Ditch. The lack of a riparian buffer and limited pool and riffle development characterized the habitat quality at this site (Figure 63). The channel had moderate sinuosity with fairly well developed channel morphology. The channel cross section showed that the stream was fairly shallow (less than 0.75 feet) for its width (3.55 feet) relative to other sites in the Curtis Creek Watershed. The substrate was predominantly sand (80%) with some cobble, gravel, and silt. The QHEI score of 37 reflects the relatively poor habitat quality of this site. The mIBI score of 2.75 is also indicative of the impaired conditions present in Yeoman Ditch. The *Dipteran* family *Chironomidae* and the *Hemipteran* family *Notonectidae*, both highly tolerant taxa, dominated the macroinvertebrate community.

FIGURE 63. Site 2 sampling location on Yeoman Ditch.

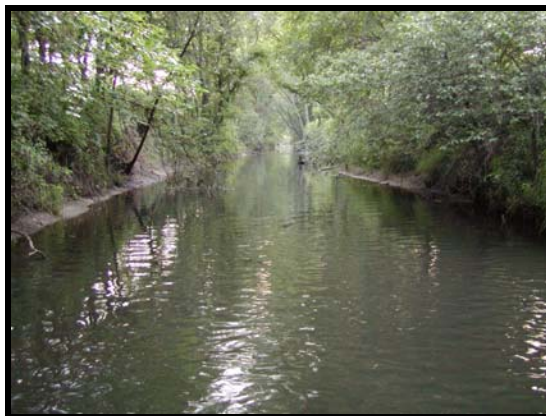
Site 3 – Curtis Creek Golf Course. This site received the highest QHEI score of any of the Curtis Creek sites, 43 of 100 total possible points. Sand dominated the substrate at this site; gravel, cobble, and silt were also present. Root wads, undercut banks, and woody debris provided in-stream cover (Figure 64). Young trees and grasses dominated the riparian vegetation. Riffle development and sinuosity were non-existent indicating little or no recovery from past modification. The mIBI score was the highest (5.25) of any of the sites representing a “slightly”

impaired system. The *Hemipteran Gerridae* dominated the macroinvertebrate community. This taxon is relatively intolerant to habitat and water quality degradation indicating a healthier community compared to the communities at other study sites. The presence of other similarly intolerant macroinvertebrates, like individuals of the *Ephemeroptera* and *Trichoptera* orders, contributed to the higher mIBI score.

FIGURE 64. Site 3 sampling location on Curtis Creek.

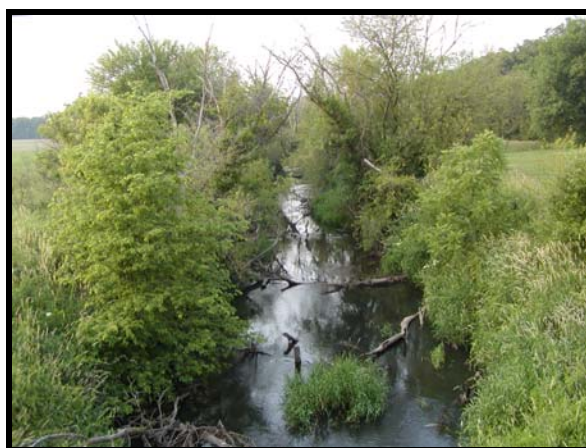
Site 4 – Curtis Creek at State Road 114. This site received a QHEI score of 38 out of a possible 100. The extensive embeddedness and poor substrate composition of sand and muck resulted in the worst substrate score of the study receiving only 2 of the possible 20 points. Bank erosion was evident along the stream channel, which was straight and channelized. Grasses and shrubs vegetated the narrow riparian zone (Figure 65). Large woody debris, aquatic macrophytes, overhanging vegetation, and root wads provided in-stream habitat. The stream cross-section showed that the stream was the widest (8.3 feet) and deepest (3 feet) of any of the sampling sites (Figure 61). The mIBI score of 3.0 reflected slightly better habitat and water quality relative to other sites. The *Hemipteran* family *Notonectidae* dominated the “moderately” impaired system. The presence of relatively intolerant taxa and high community diversity elevated the score compared to other study sites.

FIGURE 65. Site 4 sampling location on Curtis Creek.

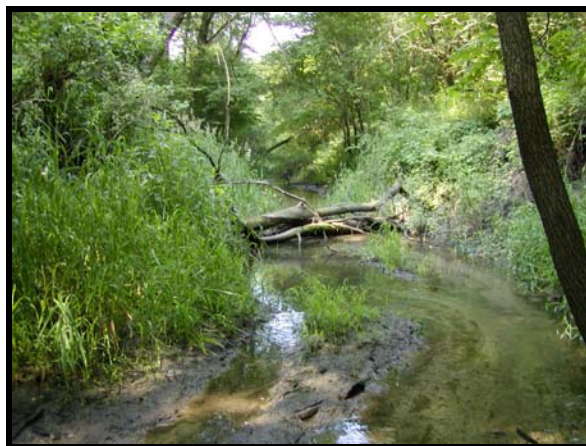
Site 5 - Long Ditch. The QHEI score for this site was 42, the second highest score assessed during the study. Sand, gravel, and silt composed the channel substrate. Trees and grasses dominated the riparian zone vegetation. Overhanging vegetation, root wads, aquatic

macrophytes, and woody debris provided habitat diversity within the stream (Figure 66). The mIBI score (2.25) was indicative of an impaired macroinvertebrate community. The tolerant *Dipteran* family *Chironomidae* dominated the insect community. The absence of individuals from the *Ephemeroptera*, *Plecoptera*, and *Trichoptera* orders lowered the score suggests that anthropogenic disturbance has limited water and habitat quality at this site.

FIGURE 66. Site 5 sampling location on Long Ditch.

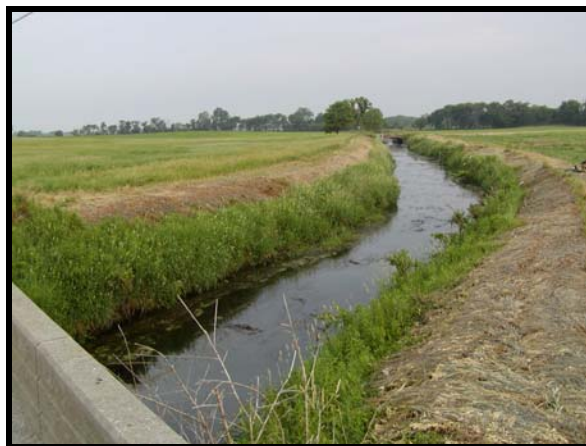
Site 6 – Curtis Creek at County Road 100 South. Channelization and limited pool and riffle development characterized the habitat at this site. The creek at this site lacked any resemblance to a natural waterway in that it was very straight and showed no recent recovery from channelization. Curtis Creek at this site also received poor pool quality scores (Figure 67). There was no riffle formation observed at the site. This stream's cross-section showed that the stream was fairly deep (2.5 feet) for its width (6.9 feet; Figure 61) compared to other study sites. The riparian zone was comprised of grasses with little or no shrubby or woody vegetation. Some aquatic macrophyte growth within the stream channel provided limited in-stream cover. The substrate was predominately sand with some gravel and fine particulate organic matter (FPOM) or muck. The site's QHEI score of 27, the second lowest, reflects the relatively poor habitat quality of this site. The mIBI score of 3.75 is also an indicator of impaired conditions. Although a good diversity of organisms was collected, a lack of intolerant taxa characterized the macroinvertebrate community.

FIGURE 67. Site 6 sampling location on Curtis Creek.

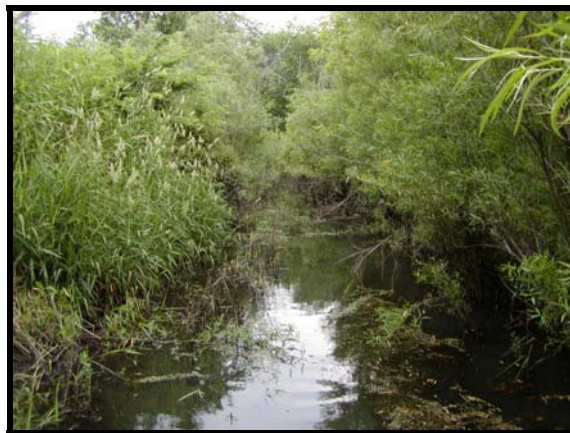
Site 7 – Elijah Ditch. The QHEI score for this reach was 36 out of a possible 100. Sand dominated the substrate; FPOM and silt were also present within the reach. Narrow riparian buffers vegetated with grasses and shrubs bordered the adjacent agricultural field (Figure 68). Woody debris, overhanging vegetation, and aquatic macrophytes provided moderate habitat diversity in the stream. No pool or riffle development was present within the reach further detracting from the QHEI score. The mIBI score for the site was 2.25, reflecting a “moderately” impaired community. Although the site supports a large diversity of macroinvertebrate taxa, the dominant families, *Chironomidae*, the *Gastropod Physidae*, and the *Coleopteran Psephenidae*, are all moderately tolerant. The low EPT metric scores reduced the overall score due.

FIGURE 68. Site 7 sampling location on Elijah Ditch.

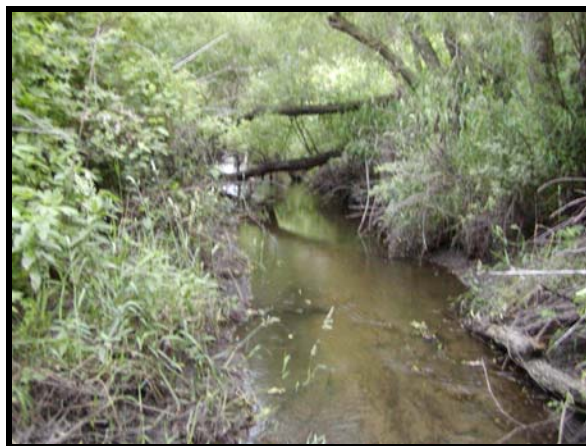
Site 8 – Kosta Ditch. Small trees and shrubs directly bordered Kosta Ditch providing moderate canopy cover (Figure 69). Although the riparian zone was comprised of woody vegetation, this zone was very narrow and provided little buffering from the adjacent agricultural fields. Overhanging vegetation, shallows, aquatic macrophytes, and woody debris provided in-stream habitat diversity. Even though canopy and in-stream cover were readily available, the QHEI score of 36 indicated that other habitat characteristics were of poor quality. Heavy siltation was evident and the substrate was predominantly sand. Riffles and pools, though present, were poorly developed. The mIBI score for the site was 3.0 indicating “moderate” impairment. The score was influenced by the dominance of relatively tolerant taxa such as *Chironomidae* and the absence of EPT taxa.

FIGURE 69. Site 8 sampling location on Kosta Ditch.

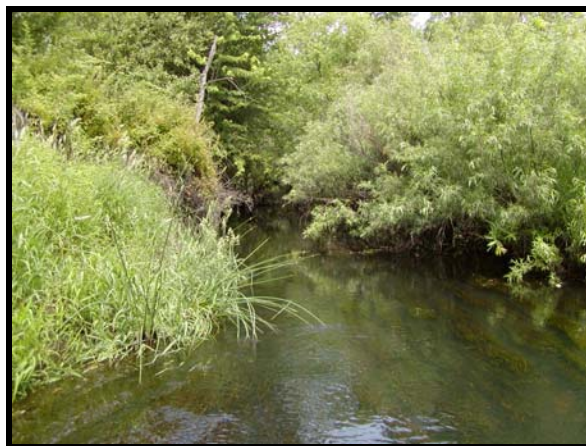
Site 9 – Curtis Creek at the Headwaters. Site 9 also received the second highest QHEI score of the study (42). Substrate composition was 35% sand, 25% gravel, 25% silt, and 15% cobble. The channel lacked sinuosity, showing no recovery from historical channelization at this site (Figure 70). The creek channel was buffered by a narrow riparian zone vegetated with young trees and shrubs. Aquatic macrophytes, woody debris, and overhanging vegetation provided in-stream cover. Pools and riffles were poorly developed. The mIBI score was 2.5, an indication of “moderate” impairment. The very tolerant bivalve *Sphaeriidae* dominated the macroinvertebrate community. Although moderate diversity of organisms was collected a lack of intolerant taxa and the absence of individuals from the orders *Ephemeroptera*, *Plecoptera*, and *Trichoptera* lowered the overall score.

FIGURE 70. Site 9 sampling location on Curtis Creek.

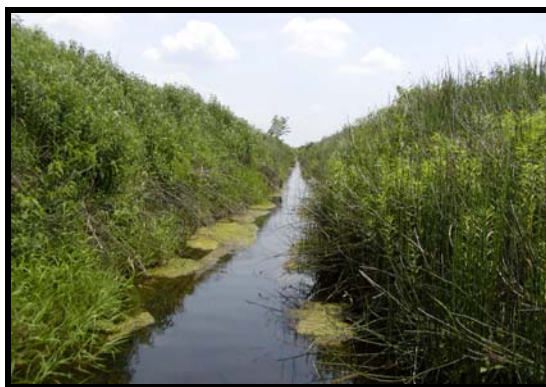
Site 10 – Unnamed Tributary. The QHEI score for this site was 23, the lowest score of the study. The substrate was comprised of 95% sand and 5% silt and was moderately imbedded. The site was directly adjacent to agricultural fields, but possessed a narrow, grassy riparian zone (Figure 71). Some aquatic vegetation was observed within the channel, but otherwise the channel had no signs of habitat cover or canopy shading. The ditch’s wetted width was approximately 2.5 feet and the depth in the channel was 1.5 feet with no pool or riffle development. The channel banks are steep and greater than 6 feet high. The mIBI score (2.25) was also the lowest of any of the sites. The tolerant families *Chironomidae* and *Physidae* dominated the macroinvertebrate sample, which lowered the HBI metric of the mIBI score. The under-representation of individuals from the orders *Ephemeroptera*, *Plecoptera*, and *Trichoptera*, which are expected to comprise larger portions in healthier communities, also reduced the overall score.

FIGURE 71. Site 10 sampling location on the Unnamed Tributary.

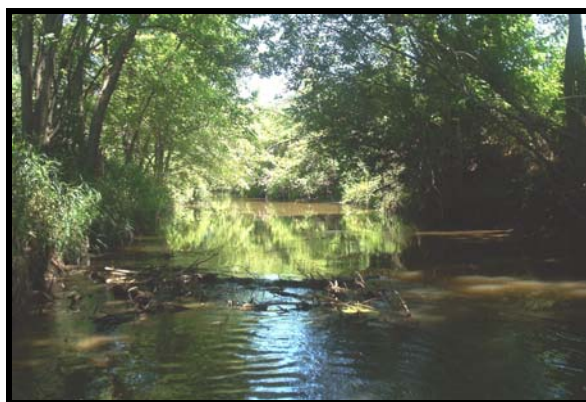
Reference Site – Beaver Creek. This site received the highest QHEI score, 68 of a possible 100. Substrate composition consisted of 40% gravel, 30% cobble, and 20% sand and boulder. Normal siltation and moderate embeddedness was evident throughout the reach. In-stream cover was extensive resulting in the highest score for the cover metric of the QHEI (Figure 72). Channel development was good, and the channel was moderate stable. A wide, forested riparian zone bordered the stream and no stream bank erosion was present. In-stream vegetation, root wads, overhanging vegetation, and deep pools provided additional habitat diversity. Riffles and pools were moderately well developed throughout the site. The mIBI score was the highest of any site. The score of 6.0 classified the site as non-impaired. The dominant macroinvertebrates were relatively intolerant taxa; the *Trichopteran Hydropsychidae* and the *Ephemeropteran Heptageniidae*, were the most prevalent macroinvertebrate taxa. The presence of *Hydropsychidae*, an EPT taxon, benefited the mIBI score; however, their rather high dominance (51%) did detract from the score. This is as expected because a more evenly distributed community is expected in a healthy system.

FIGURE 72. Reference site sampling location on Beaver Creek.

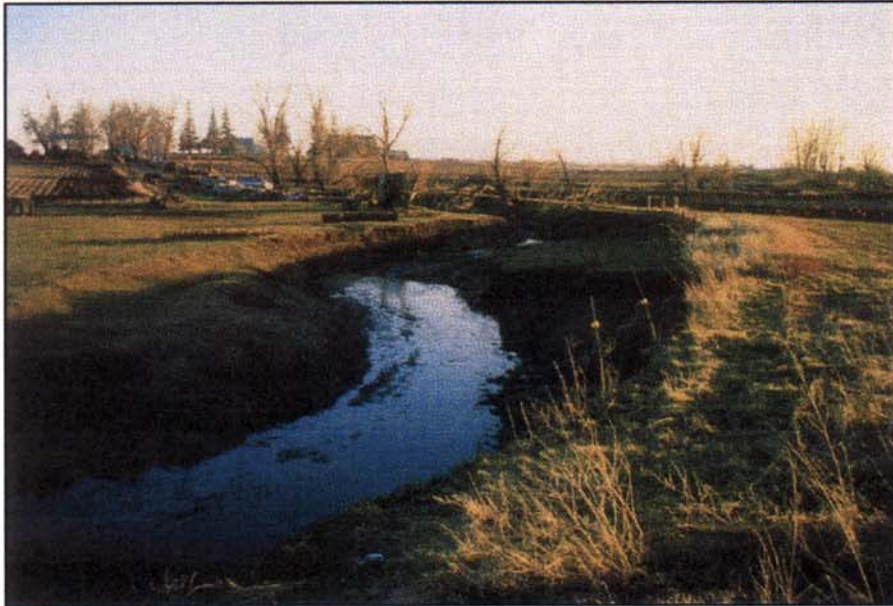
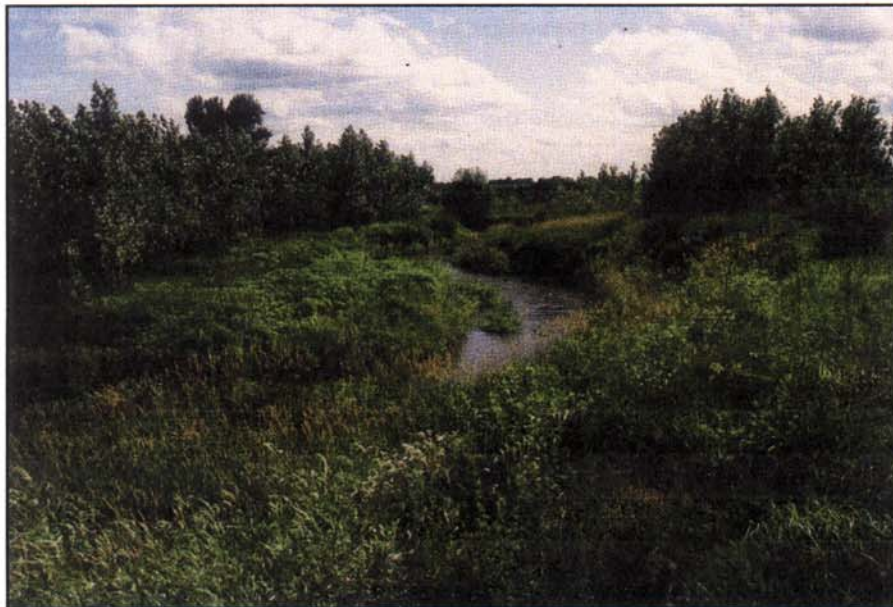
Bear Creek riparian management site from the Isenhardt et al., 1997 study. Top photo shows site in March 1990, prior to buffer strip establishment. The bottom photo shows the same site in June 1994 after five growing seasons. Used with permission from the American Fisheries Society.

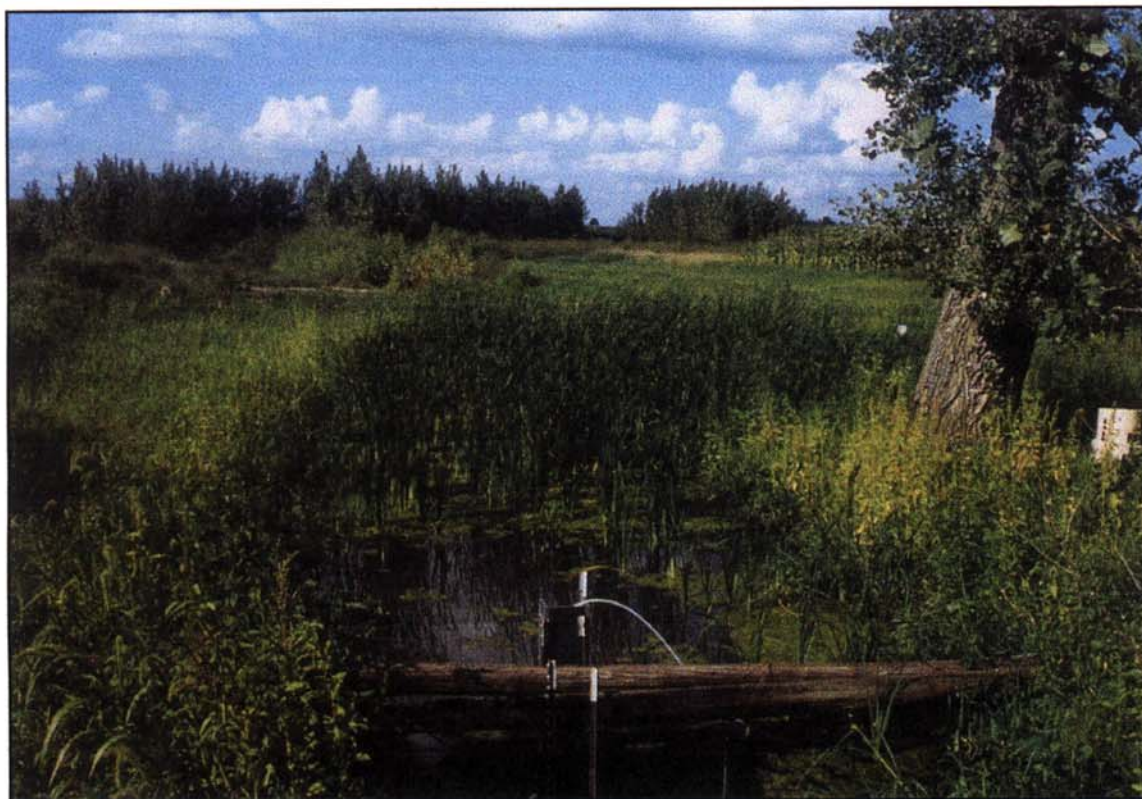
Wetland component of the Bear Creek riparian management system model from the Isenhardt et al., 1997 study. Photo was taken in August 1994, a few months after construction. The water control structure can be seen in the foreground. Used with permission from the American Fisheries Society.
